Rainbow SkyReach (Pty) Ltd

SERVICE BULLETIN

IMPORTANCE	HIGH
AREA AFFECTED	Engine Mount Adapter
SA/B NUMBER	CH 012 06-2019
EFFECTIVE DATE	24 June 2020

Inspection of the four M10 x 30mm bolts that attach the engine mount adapter to the engine mount.

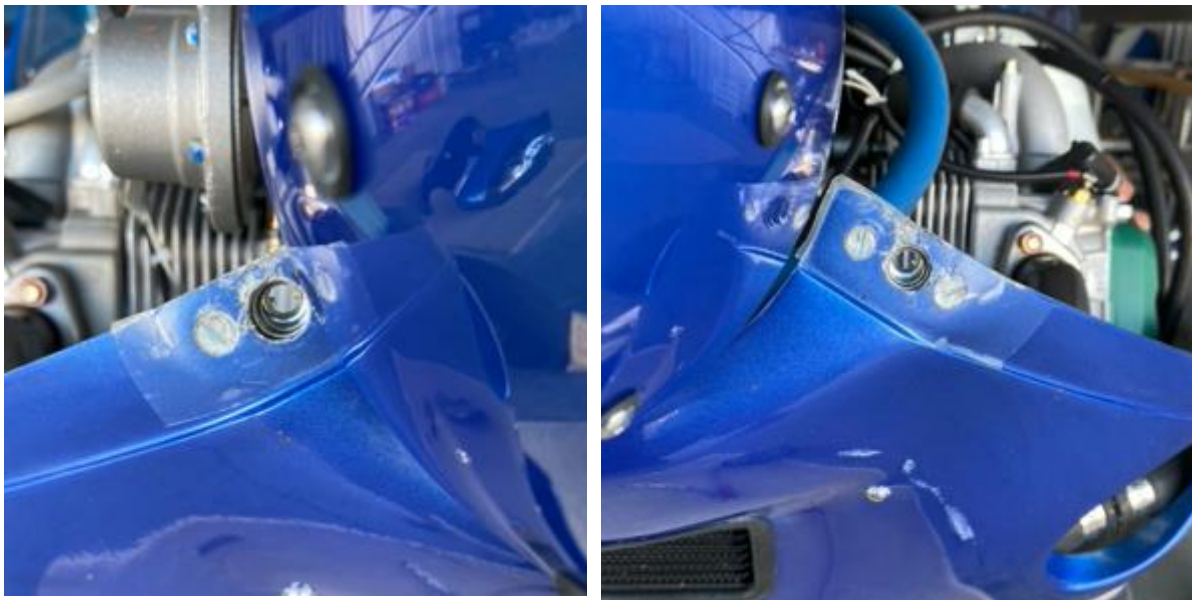
During the course of a pre-flight inspection on a kit-assembled aircraft with 50 hours total time, for which the parts were packed in May of 2017, it was noticed that the engine seemed to have shifted slightly to the right in the engine compartment. It was found that the rubber engine mounts were not properly seated in the engine mount which had resulted in the engine mount adapter and engine shifting slightly in the engine bay as can be seen by comparing the relative positions of the front DZUS fasteners on the cowling to the spinner in Figure 1. The engine had also shifted forward, resulting in the oil filter housing coming into contact with the lower oil radiator as shown in Figure 2.

Figure 1 – Engine shifted to the right

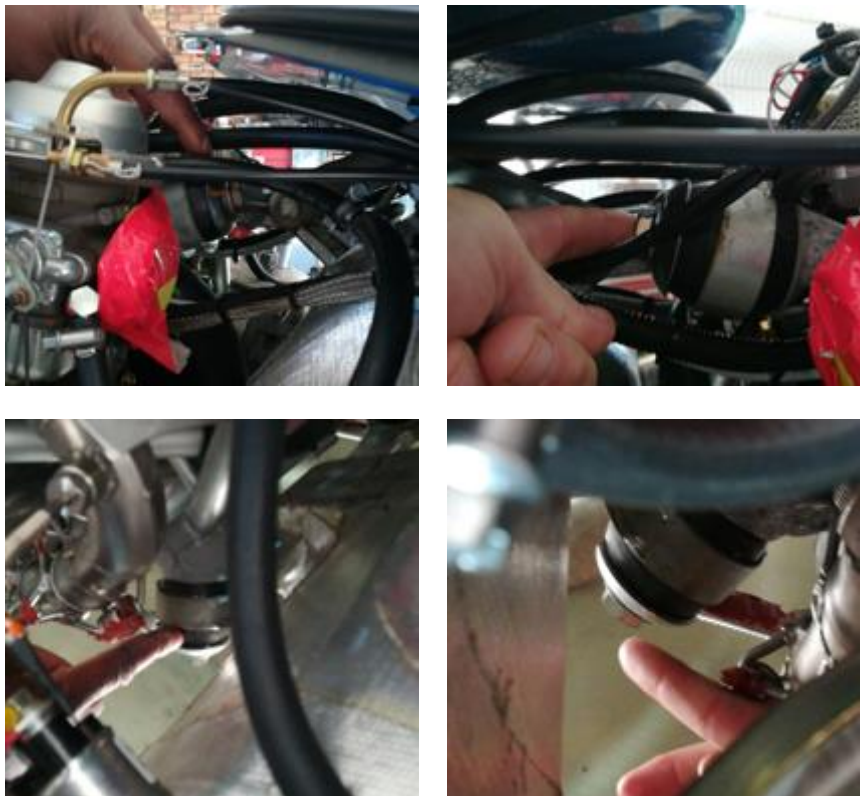
1. All aircraft must be inspected visually by the operator before further flight. Steps 2 and 3 are only symptoms of the problem and if any of those two checks hold true, step 4 will still need to be checked to confirm that a defective engine mount adapter rod is the cause.
2. Check for a noticeable lateral shift in the engine by comparing the location of the front DZUS fasteners to the spinner.
3. Check for the oil filter housing chaffing on the lower oil radiator.
4. Check visually for any of the four engine mount adapter bolts which are not properly fastened, visible threads under the bolt head, as in Figure 4, would indicate that this is the case. The bolts to inspect are shown in Figure 7.

Figure 7 – Bolts requiring inspection

5. If a defective mount has been identified the factory should be notified immediately and the aircraft is to be grounded until the problem has been addressed.

To circumvent the problem a shorter length, Grade 8.8 Zinc Plated M10 bolt may be used which would not extend past the threaded section in the rod and would therefore not bottom out. At the time of publishing this service bulletin it had not been determined whether a M10 x 25mm or a M10 x 20mm would be the best replacement option. The factory will supply the best replacement option at no cost to the operator, we recommend using only approved bolts supplied by the factory since we cannot guarantee that the material and geometrical properties of your local hardware store bolts will be correct.

The two lower bolts may be removed as is, you may just have to remove the lower cowling to gain access to the engine mount. The upper bolts are slightly more complicated since the weight of the engine would need to be fully supported on an appropriate engine hoist before loosening the top bolts.

When inserting the new bolts ensure that the washers (and exhaust plate for the lower mounts) are inserted back in the same order that they were in when removed.
